# USS Wahoo (SS238) Side Scan Sonar Comparison

Possible explanations of side scan imagery

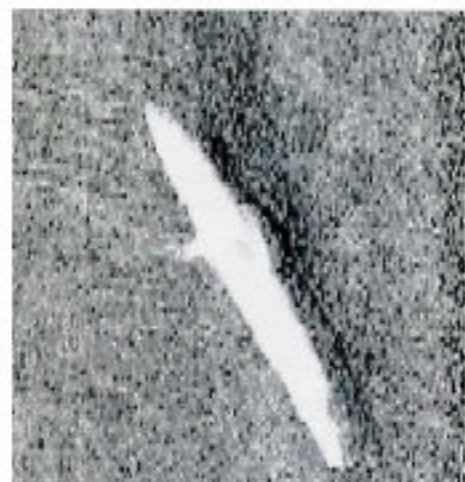
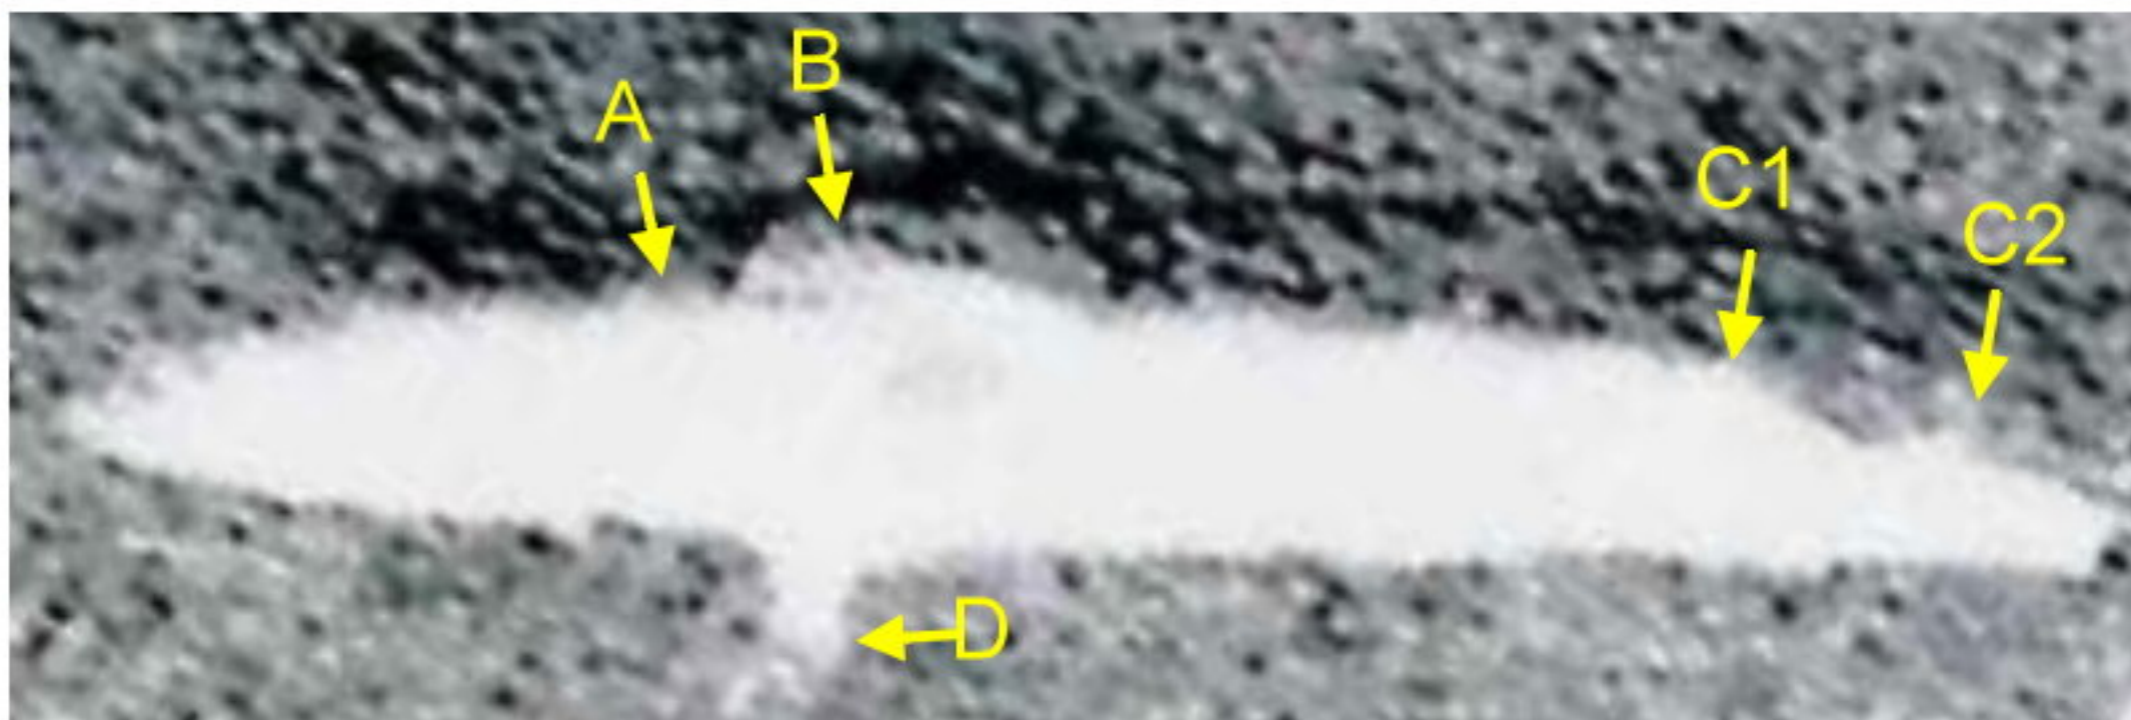
Image 1  
Side Scan Sonar  
Mid 2004

Original Image Orientation

Image width approx. 8 meters, length approx. 90 meters.

Key:

A: 4" deck gun

B: Bridge fair weather and conning tower

C1-C2: After torpedo section - note the decline from the stern deck (C1 to C2).

D: Unknown structure - perhaps battle damage, fishing nets, or other formation. This section of the boat housed the pump room and the periscope wells.
